Manhole Inspection Summary

Manhole # S29SS_009MH

Insp Date: **5/15/07 10:09 AM**

Location Address: **3100 Sisson St**

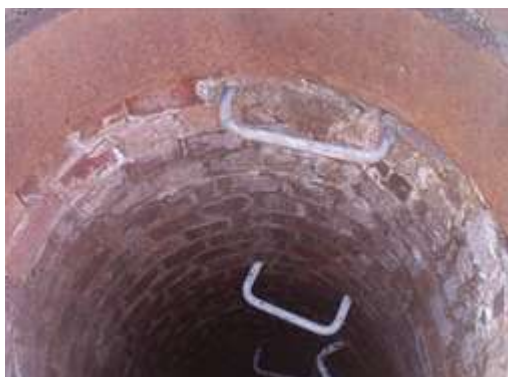
Defect

Infiltration: ☐ None ☒ **Joint** ☐ Cracks ☐ Mortar ☐ Roots ☐ Wall

adjustment joint, loose brick

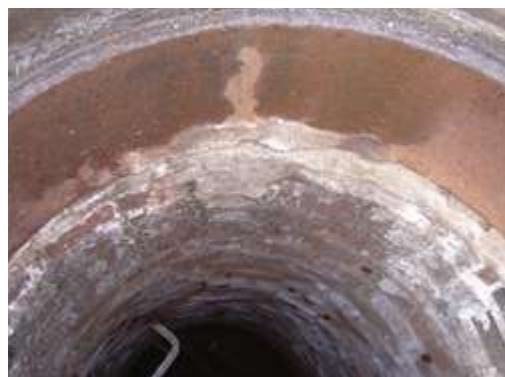
Defect

☒ **Leaks**

frame leaks

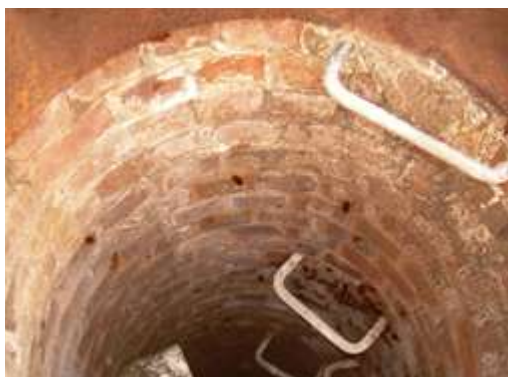
Defect

Infiltration: ☐ None ☐ Joint ☐ Cracks ☐ Mortar ☐ Roots ☒ **Wall**

infiltration in mh

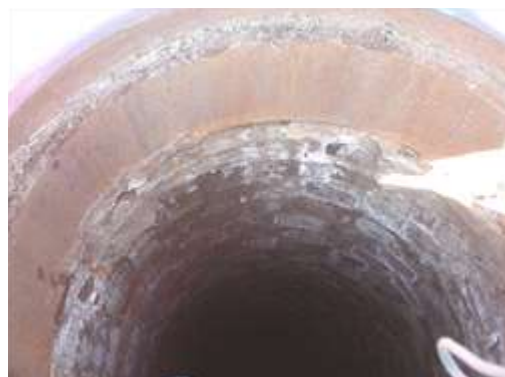
Defect

frame leaks

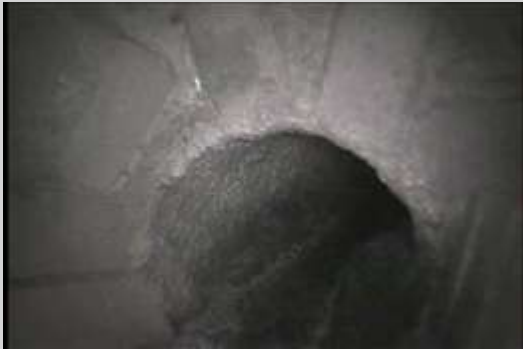
8 in. Circular Gravity Sewer Pipe Out @ 12 O'Clock

Pipe Material: **Clay** ☐ Pipe Lined

Invert Depth: **16.72** (ft.) Flow Characteristics: **Slow**

Infiltration: **None** Pipe Seal Cond: **Sound**

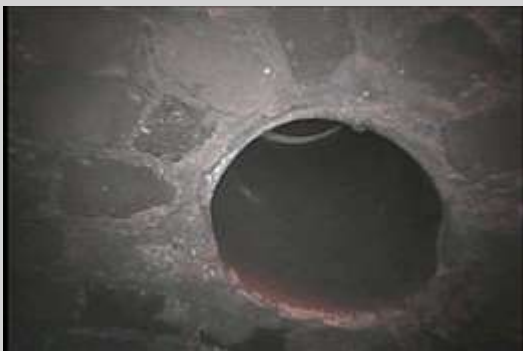
8 in. Circular Gravity Sewer Pipe In @ 6 O'Clock

Pipe Material: **Clay** ☐ Pipe Lined

Invert Depth: **9.46** (ft.) Flow Characteristics: **Slow**

Infiltration: **None** Pipe Seal Cond: **Sound**

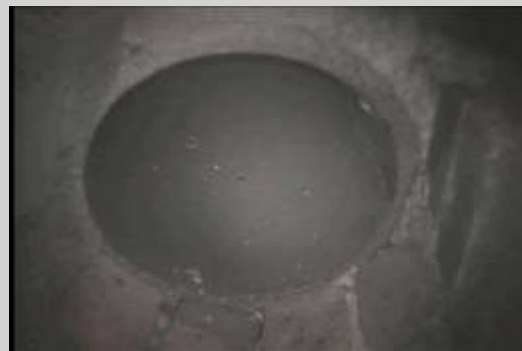
Drop In @ 6 O'Clock

Drop: **Outside** Rod and Bar

Drop Condition: **Open**

Connects To: **Dead End**

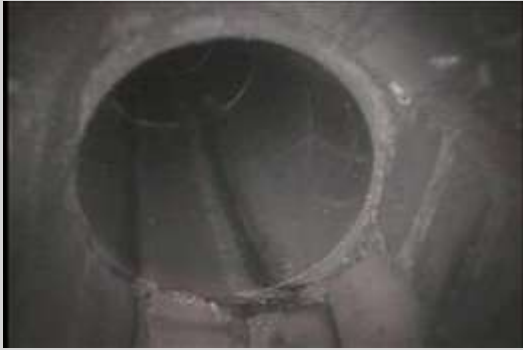
Pipe In @ 8 O'Clock

Pipe Material: **Clay**

Invert Depth: **15.68** (ft.) Flow Characteristics: **Slow**

Infiltration: **None**

Pipe Seal Cond: **Sound**
